# **GREY COUNTY COMMUNITY HOUSING**

## **Designated Substance Survey**

**Project Location:**  
Holstein, Ontario

This report pertains to the building at 392051 Grey Road 109, which contains 16 apartment units.

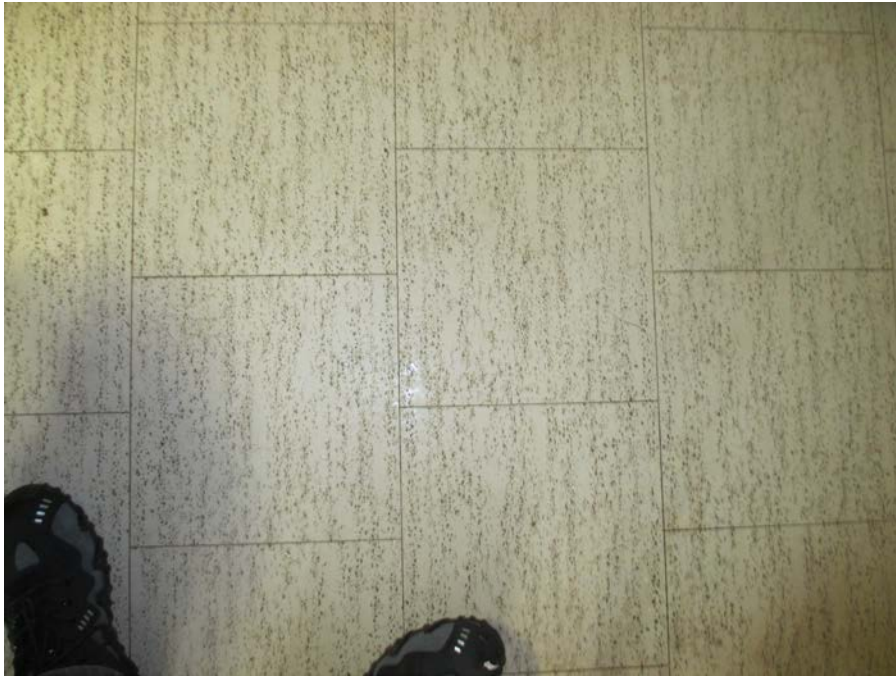
**Photograph No. 1 – Unit 107 (Front Entrance)**  
Asbestos-containing 12" x 12" white with black dots vinyl floor tile

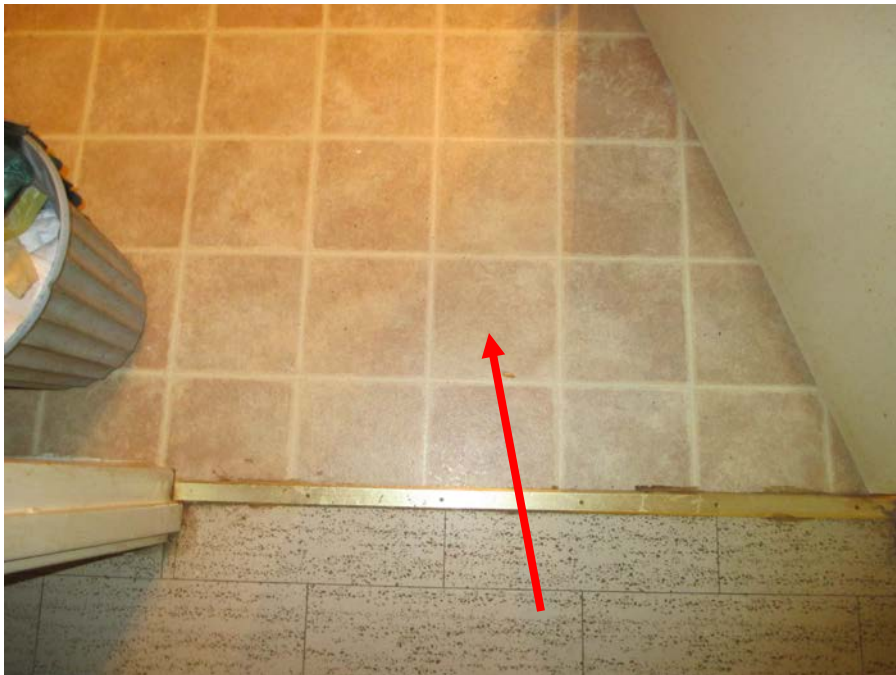
**Photograph No. 2 – Unit 107 (Washroom)**  
Asbestos-containing brown square pattern vinyl sheet flooring

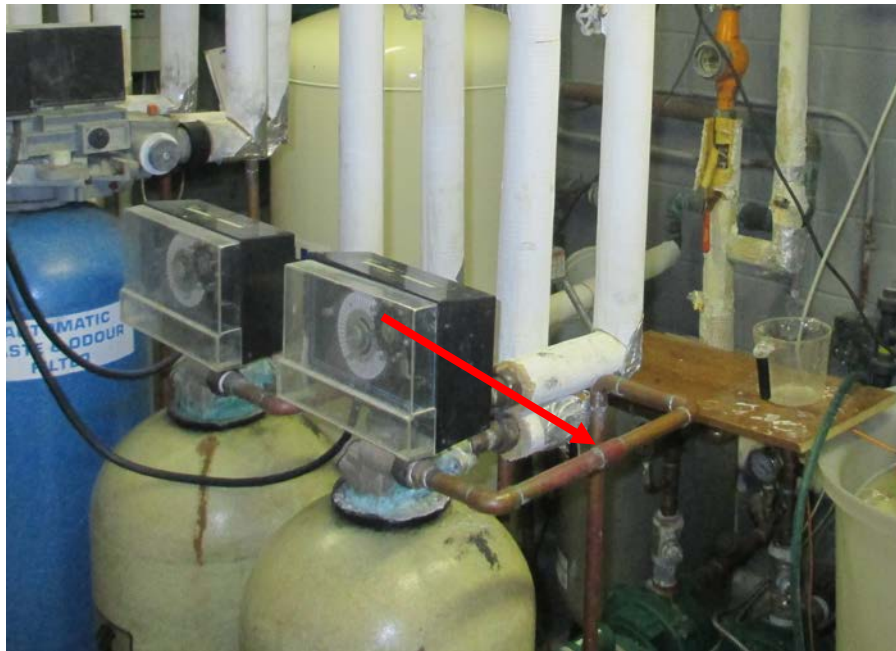
**Photograph No. 3 – 1<sup>st</sup> Floor Mechanical Room**  
Lead solder on pipe connections

Lead solder joints on domestic water supply pipes were identified during the assessment, and, as such, special management, handling and disposal requirements regarding lead apply for building renovation, maintenance, or demolition work.

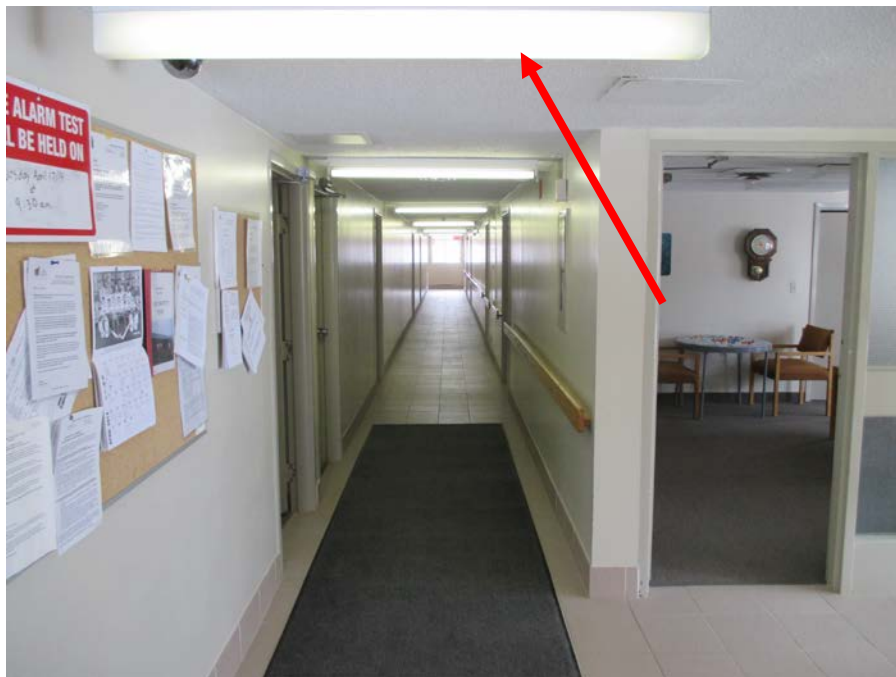
**Photograph No. 4 – 1<sup>st</sup> Floor Corridor**  
Mercury-containing fluorescent light tubes

All mercury-containing materials or sources should be removed, intact, prior to any work which may disturb or damage them and cause worker exposure to mercury liquid and/or vapour.

On-site crushing of fluorescent light tubes should not occur. Care should be taken to ensure safe storage of the above items until recycling or disposal can be coordinated. Under current legislation, mercury waste requires handling and disposal in accordance with Regulation 490/09 of the OHSA and Ontario Regulation 347 of the Environmental Protection Act respectively.
